Air Accident Investigation Unit Ireland

SYNOPTIC REPORT

**ACCIDENT
EC135P2+, 270
Near Borrisoleigh, Co. Tipperary
19 June 2012**

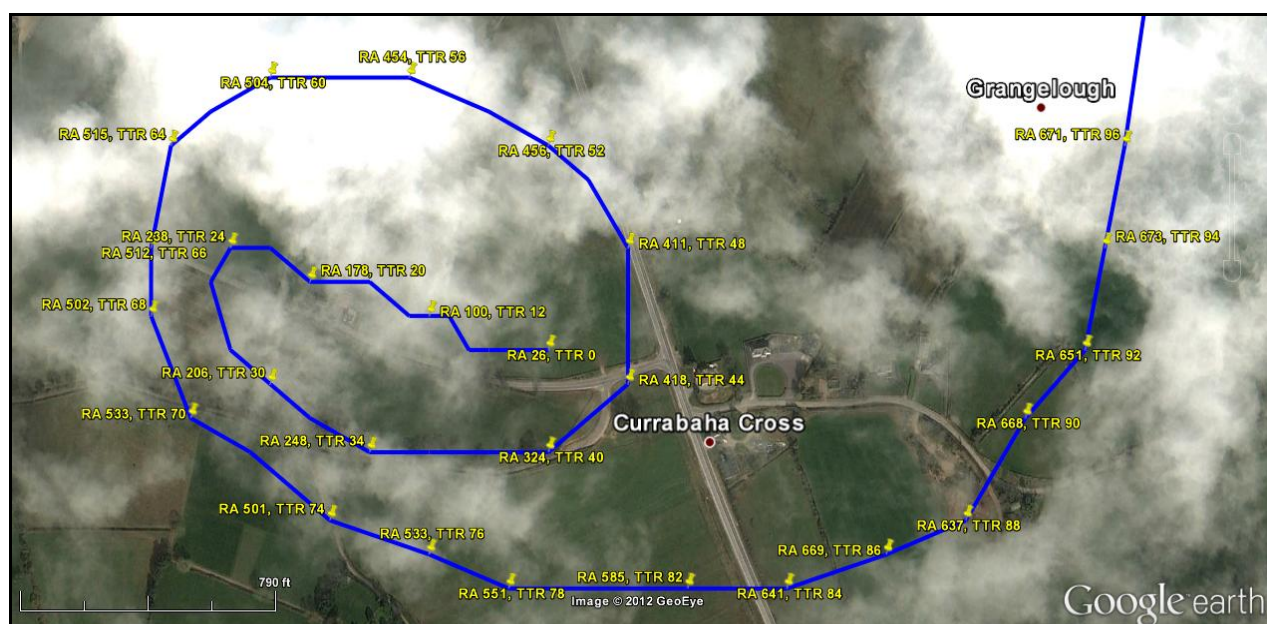
Photo No. 1: Reconnaissance Pattern Flown Prior to Landing

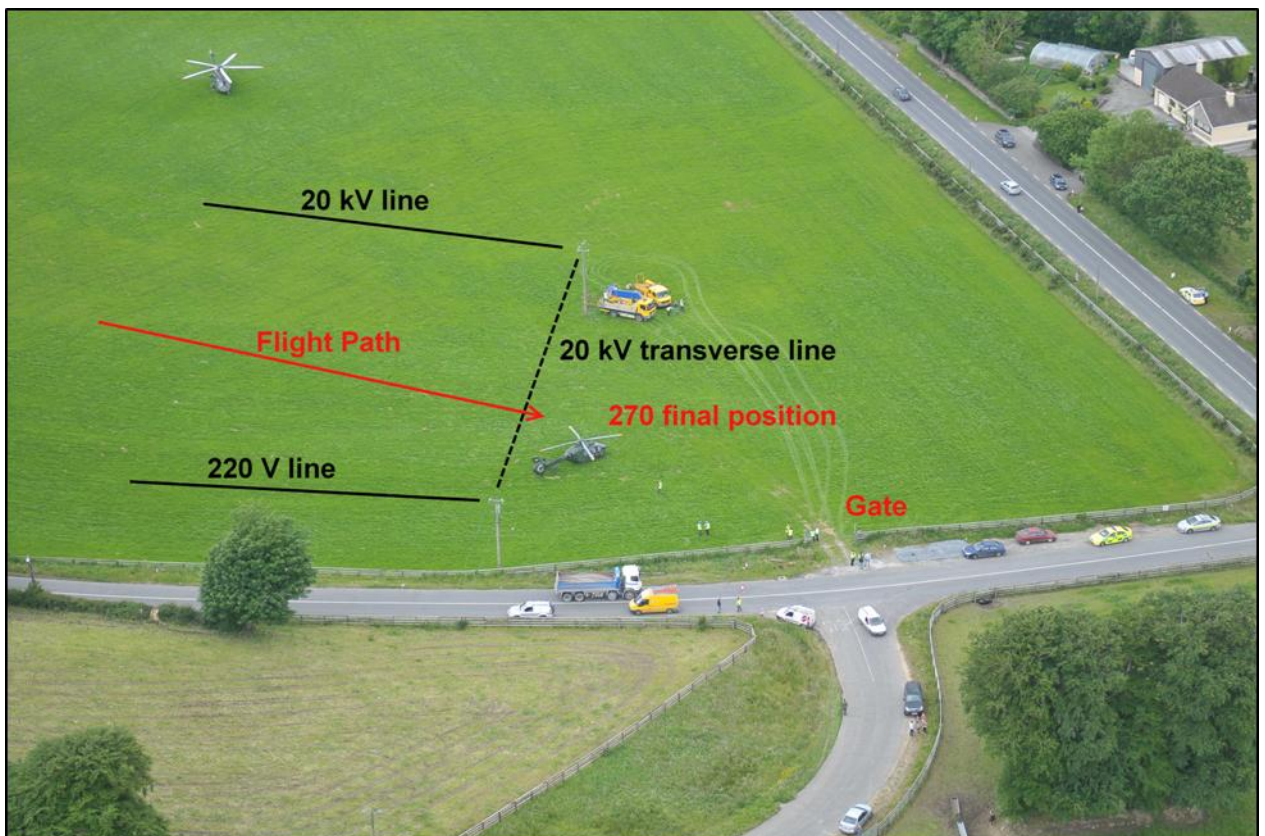
The Pilot stated that, before the landing, he managed to level the helicopter and it touched on heavily. He shut down the engines, checked that the other crewmembers were unhurt and all exited the helicopter safely. Once outside, he noted extensive damage to the helicopter. AP1 discussed the situation with AP2 from the ground support vehicle and it was agreed to transfer the patient by road ambulance to hospital in Limerick. The accident site is shown in **Photo No. 2**.

Photo No. 2: Aerial View of the Accident Site

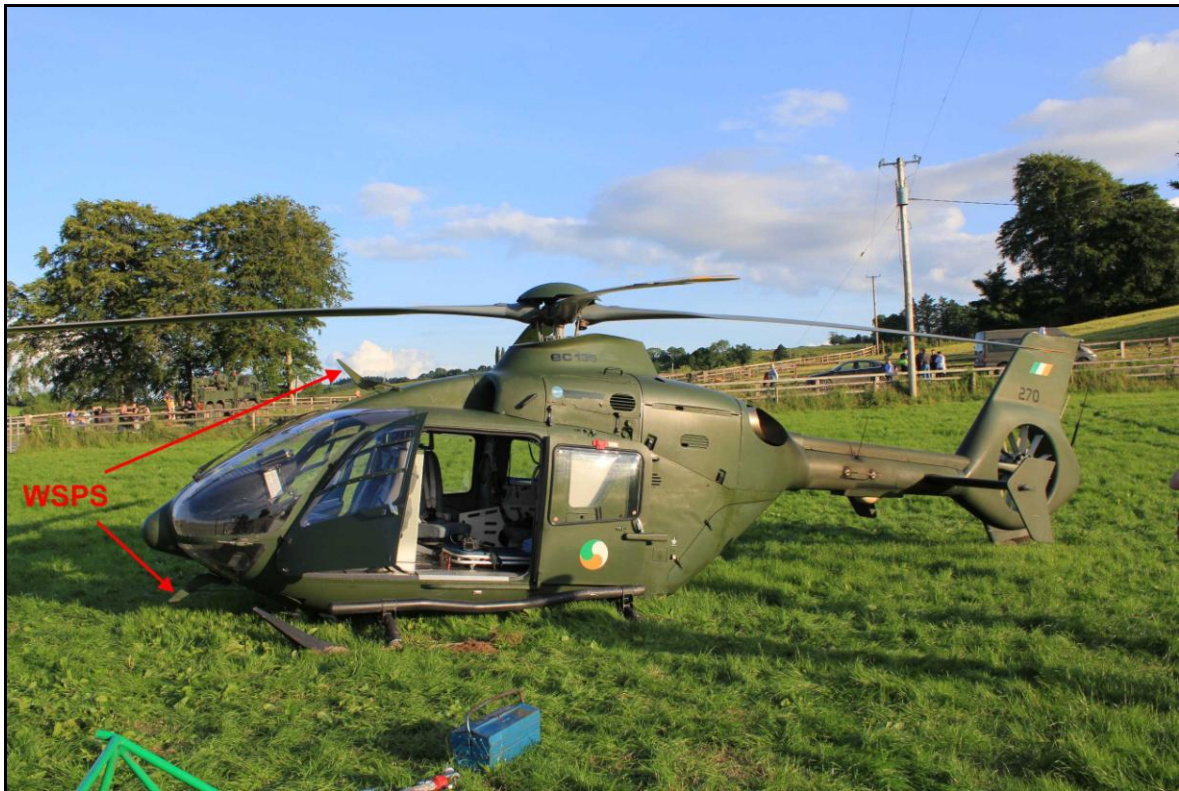
The helicopter came to rest with its tail directly between the two poles supporting the wires which had been severed. Marks created on the ground by the skids indicated that it had moved forward by approximately 50 cm from its initial impact to its final position.

The helicopter was substantially damaged in the accident. The lower structure of the fuselage including the bottom shell sustained considerable damage, several cross frames and the left-hand (LH) and right-hand (RH) keel beams were deformed and/or cracked. The bottom shell was fractured on its LH side and the helicopter's RH side panel sustained severe buckling damage.

Photo No. 3 shows the helicopter in its final position in the field following the accident. The upper and lower cutter assemblies of the WSPS are indicated in the photo.

Photo No. 3: Final Position of 270 in Field

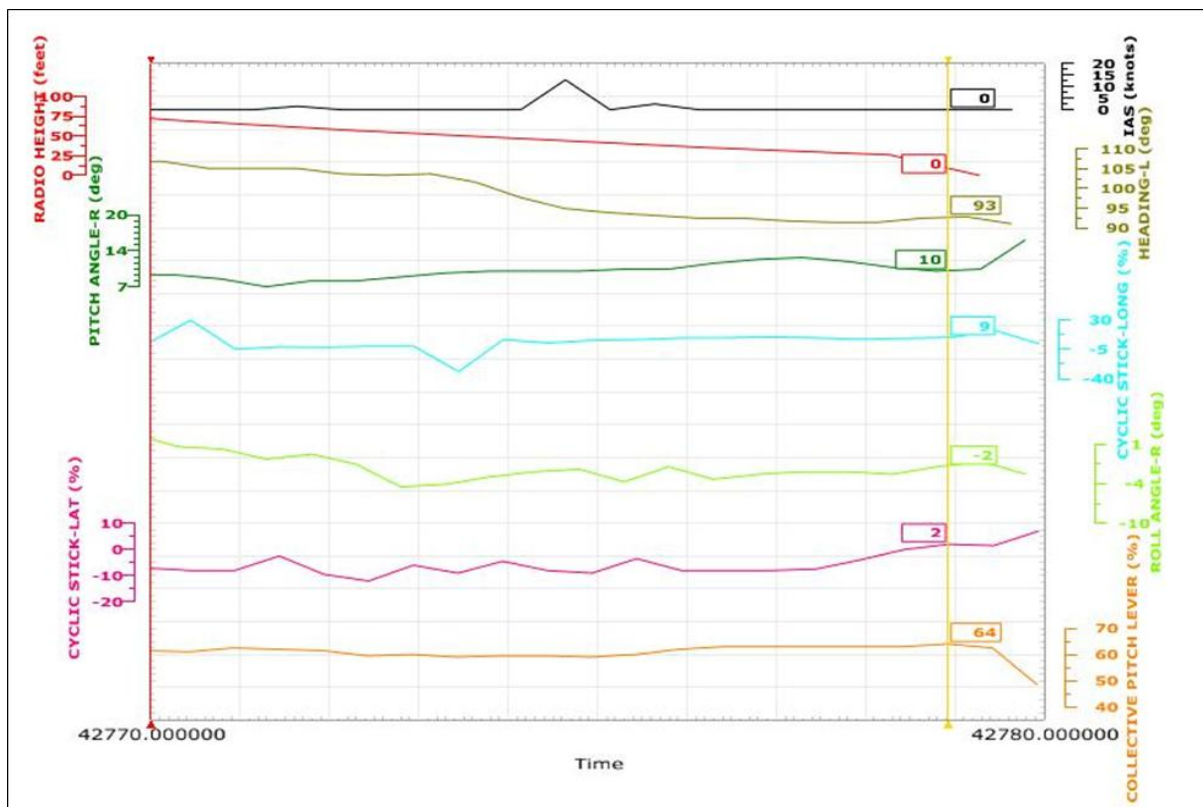
Figure No. 1 shows selected FDR parameters for the final 10 seconds of the recording. It should be noted that the data for all the parameters is sampled at certain defined time intervals. The sampling frequency for all the parameters shown in the Figure is 2 Hz, i.e. once every 0.5 secs, with the exception of radio height which is sampled once every 2.0 secs. The yellow vertical line is a nominal reference scale inserted 1.1 secs prior to the end of the recording which enables a snapshot of parameter values to be shown on the Figure. The data indicates that the helicopter was travelling at a very low airspeed on a generally easterly heading and descending steadily in a controlled fashion from 75 feet above the ground.

The data for the position of the cyclic stick in the longitudinal axis indicates that in the final second there was a rearward movement of the stick and an associated increase in pitch angle (i.e nose-up). The data for the position of the cyclic stick in the lateral axis indicates that in the final second there was a movement of the stick to the right with an associated right rolling motion. The data for the collective lever position shows no significant increase during the final two seconds whereas there is a notable decrease during the final second of recorded data.

Figure No. 1: FDR Trace of Final 10 Seconds of Recorded Data
