ACCIDENT

Aircraft Type and Registration:	AgustaWestland AW109SP, G-TAAS	
No & Type of Engines:	2 Pratt & Whitney Canada PW207C turboshaft engines	
Year of Manufacture:	2013 (Serial no: 22305)	
Date & Time (UTC):	22 April 2021 at 1247 hrs	
Location:	Carsington Water, Derbyshire	
Type of Flight:	Commercial Air Transport (Passenger)	
Persons on Board:	Crew - 2	Passengers - 1
Injuries:	Crew - None	Passengers - None
Nature of Damage:	Shattered left windshield and a hole in one main rotor blade	
Commander's Licence:	Commercial Pilot's Licence	
Commander's Age:	54 years	
Commander's Flying Experience:	4,212 hours (of which 2,944 were on type) Last 90 days - 43 hours Last 28 days - 16 hours	
Information Source:	Aircraft Accident Report Form submitted by the pilot

Synopsis

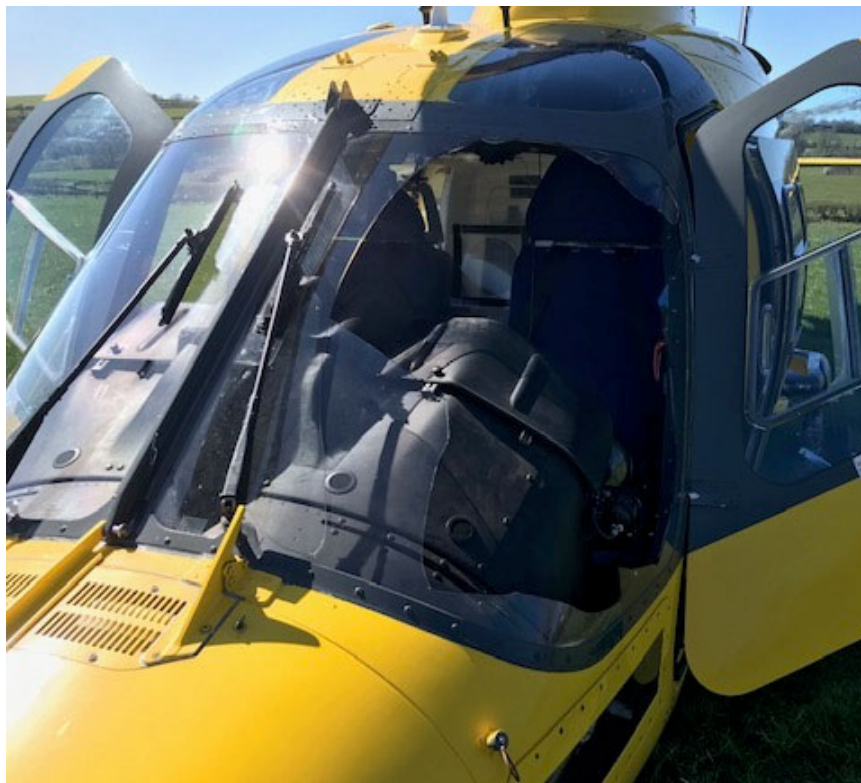
Figure 1

The left windshield, which was made of acrylic, had shattered into multiple pieces which were found throughout the cockpit and passenger area (Figure 1). Debris from the windshield also entered the main rotor disk, making a hole in the trailing edge of one of rotor blades (Figure 2).

Damage to the left windshield

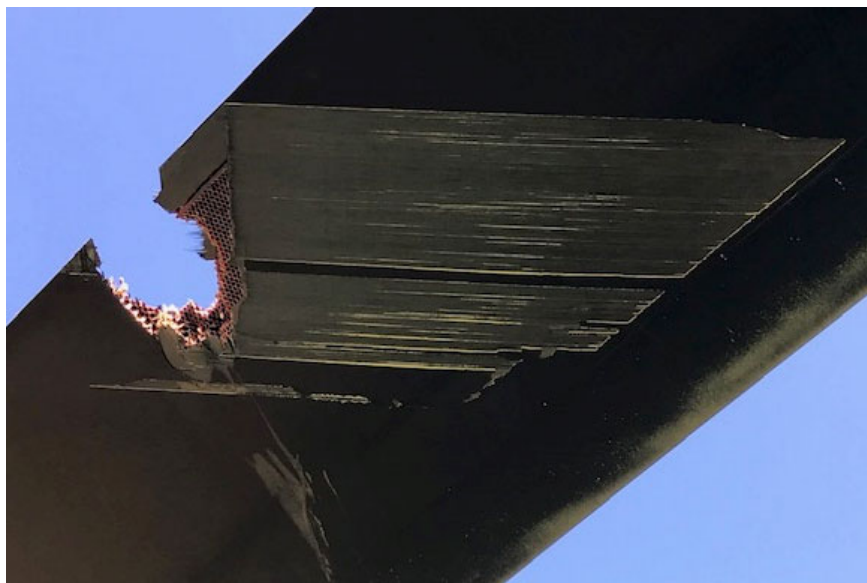
Figure 2

Main rotor blade trailing edge damage
