Aviation inquiry AO-2019-005

BK117-C1, ZK-IMX

Controlled Flight into Terrain (Water)

22 April 2019

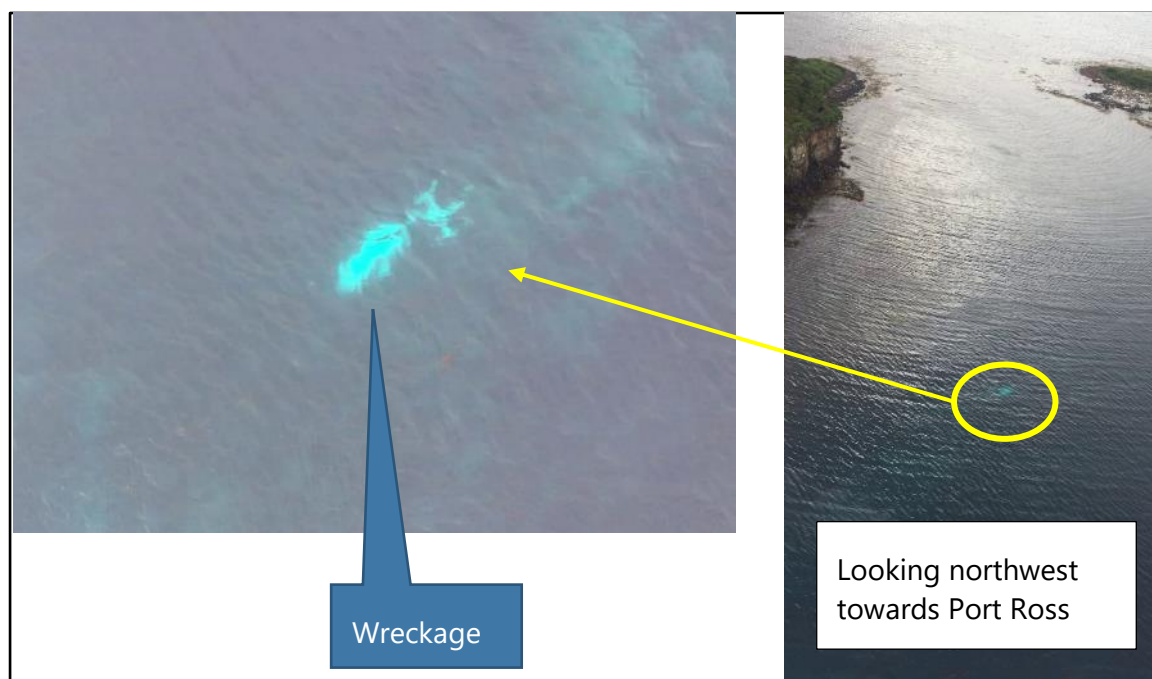
Figure 3: Wreckage location

- 2.23. The wreck was observed in the water just off the northeast coast of Auckland Islands near Ewing Island. It was upside down in water about 15 metres deep.

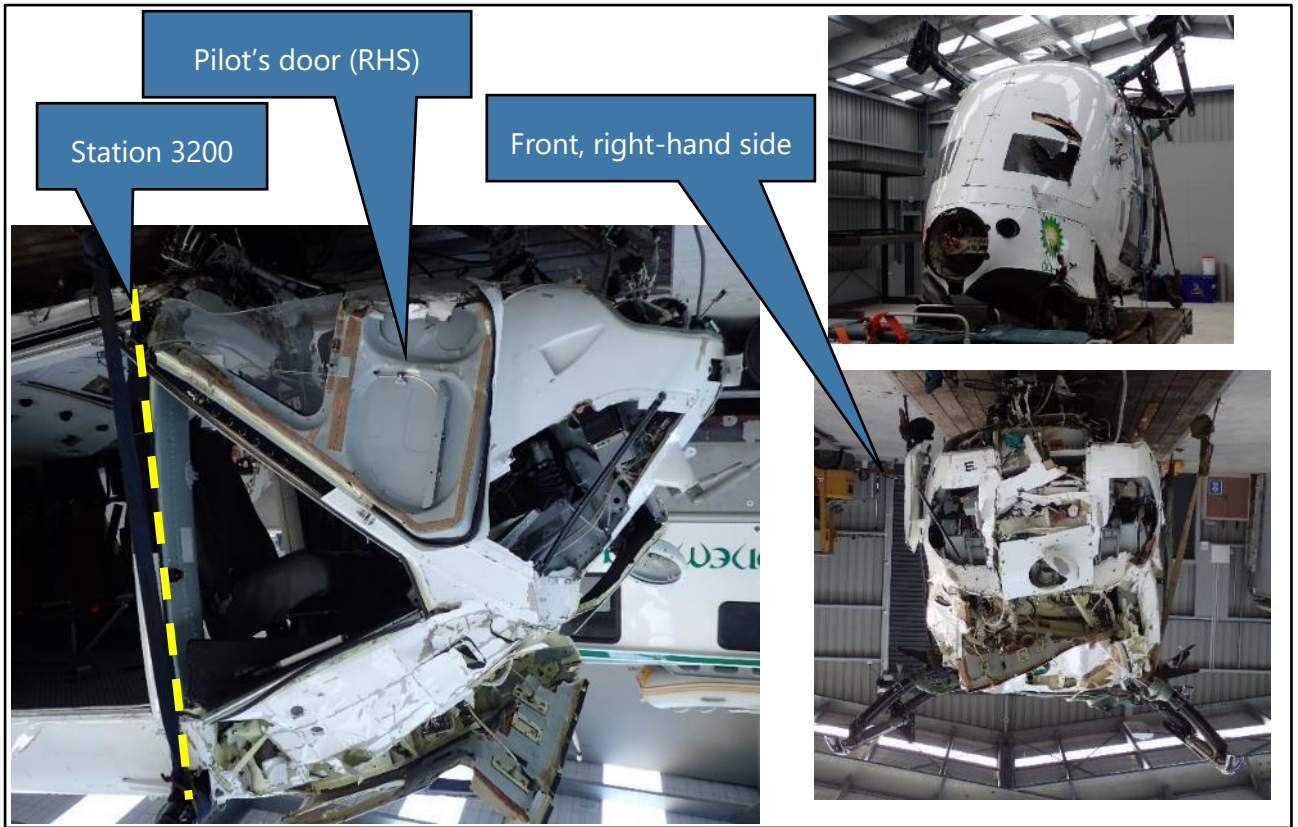
Figure 5: Exterior damage
 (images rotated except the rear view)

- 2.63. Damage to the wreckage was consistent with the helicopter impacting the water at speed, with the power on, and in a shallow angle of descent with a slight right-hand bank. The helicopter would have tipped forward until the main rotor blades contacted the water. This action would have rotated the helicopter fuselage up and around and then hard down onto the left-hand side. The transmission and rotor head and the two left-hand doors would **likely** have departed during this stage of the impact.

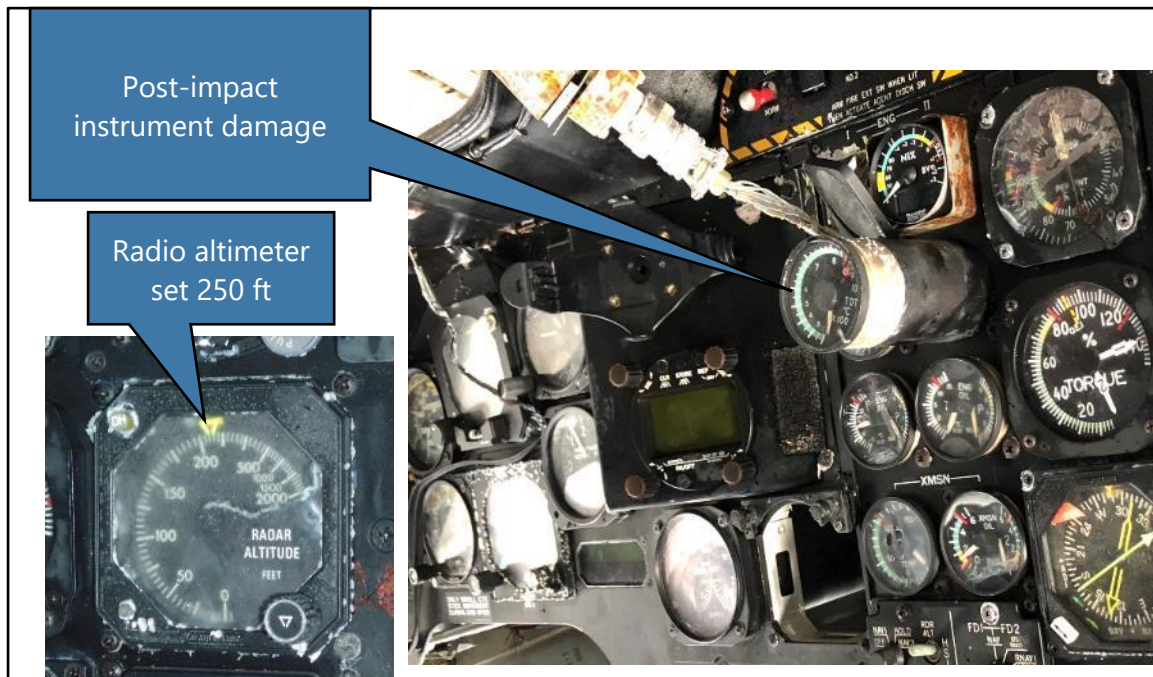
Figure 7: Instrument panel damage

- 2.62. The panels around the nose, front windows and instrument mountings were damaged by water impact. The cockpit floor had been forced upwards slightly and pivoted around a point in the floor where the front cross-brace for the skid penetrates, back towards the rear of the front door frame at station 3200¹⁵ (see Figure 5). Some instruments had slid aft in their panel mounting **very likely** due to the impact-induced water pressure in the nose area behind them (see Figure 7).

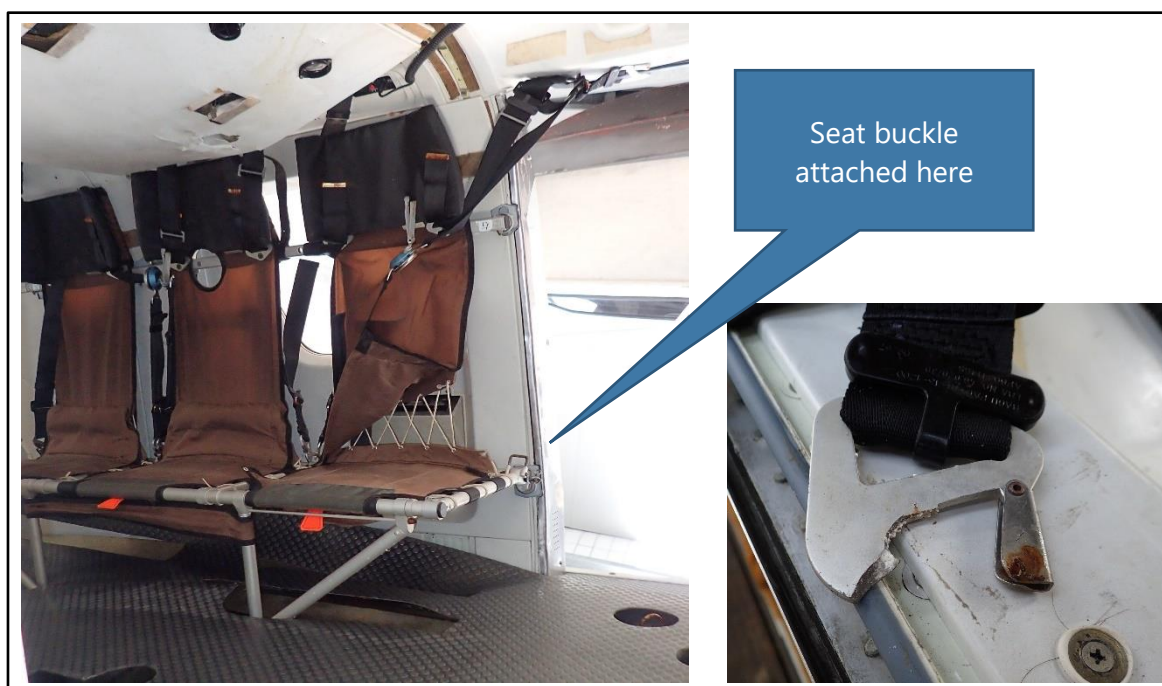
Figure 8: Winch operator's seat belt

- 2.67. The winch operator was flung forward and knocked unconscious. The sliding door detached in the accident sequence. The paramedic evacuated from the front left seat, and found the winch operator floating on their back in the cargo cabin and dragged them out of the helicopter.
