# Aviation Investigation Final Report

| <b>Location:</b> | Stagecoach, Nevada | <b>Accident Number:</b> | WPR23MA113 |
| <b>Date &amp; Time:</b> | February 24, 2023, 21:14 Local | <b>Registration:</b> | N273SM |
| <b>Aircraft:</b> | Pilatus PC-12/45 | <b>Aircraft Damage:</b> | Substantial |

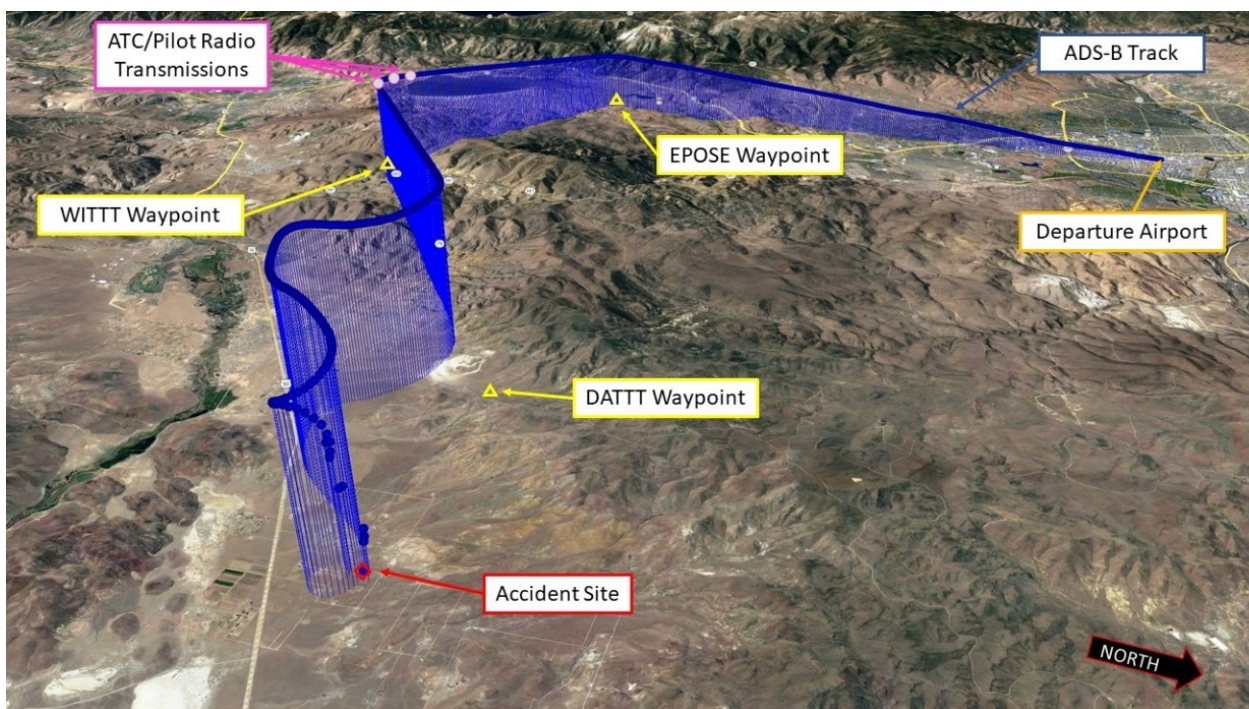
Figure 2: ADS-B flight track data with waypoint, accident site, and radio communication reference points annotated.

About 2111:15, the airplane began a right turn before reaching the DATTT waypoint, which was the next waypoint along the departure procedure. About this time, the airplane's previously consistent climb rate stopped, with the airplane continuing at an altitude of about 18,300 ft msl for about 20 seconds. The ADS-B data showed that the airplane remained on this heading for about 47 seconds and climbed to about 19,000 ft msl before turning left to a northeasterly heading. The airplane continued on a northeasterly heading and climbed to about 19,400 ft msl before entering a descending right turn about 2113:20. About 2113:30, the airplane's rate of descent increased from about 1,800 ft per minute (fpm) to 13,000 fpm, and the rate of turn increased. The airplane remained in a descending right turn until ADS-B contact was lost about 2114:12 at an altitude of 11,100 ft msl in the vicinity of the accident site. Figure 2 shows the airplane's ADS-B flight track.

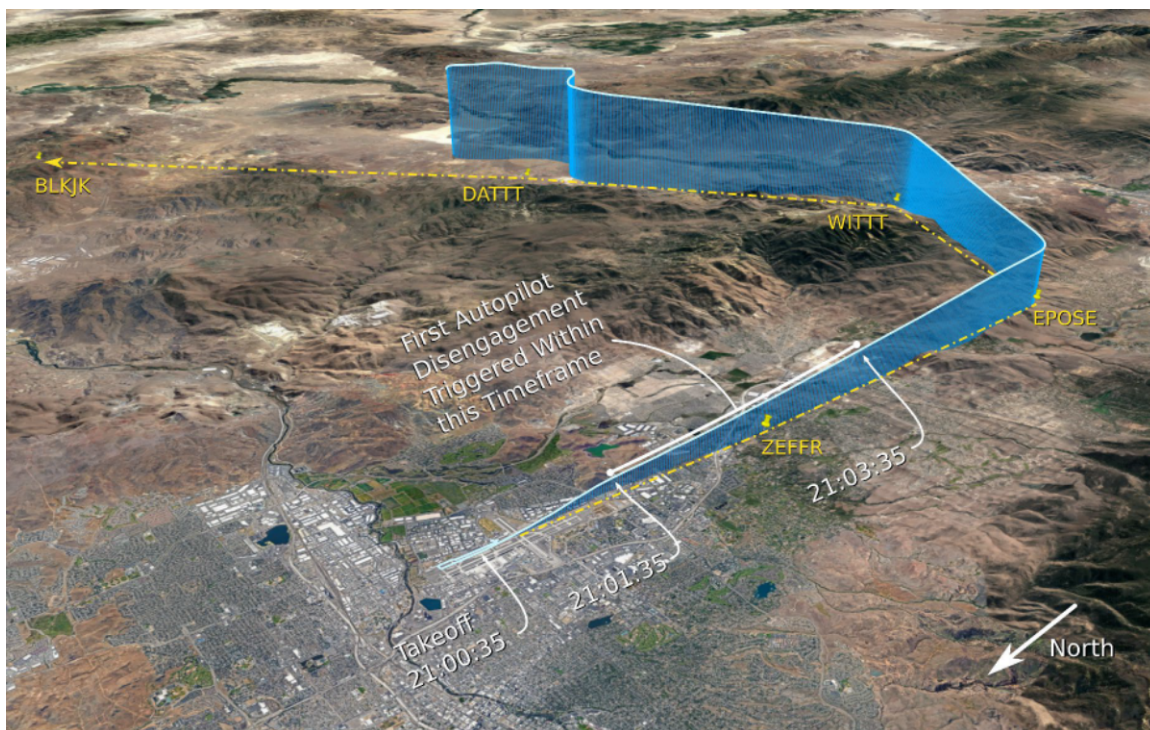
Figure 3: CAWS data map overlay showing the takeoff event and first autopilot disconnect.

The CAWS computer recorded an autopilot disengagement between 1 and 3 minutes after takeoff (between 2101:35 and 2103:35), as shown in figure 3. The CAWS data showed that the autopilot was reengaged shortly thereafter.

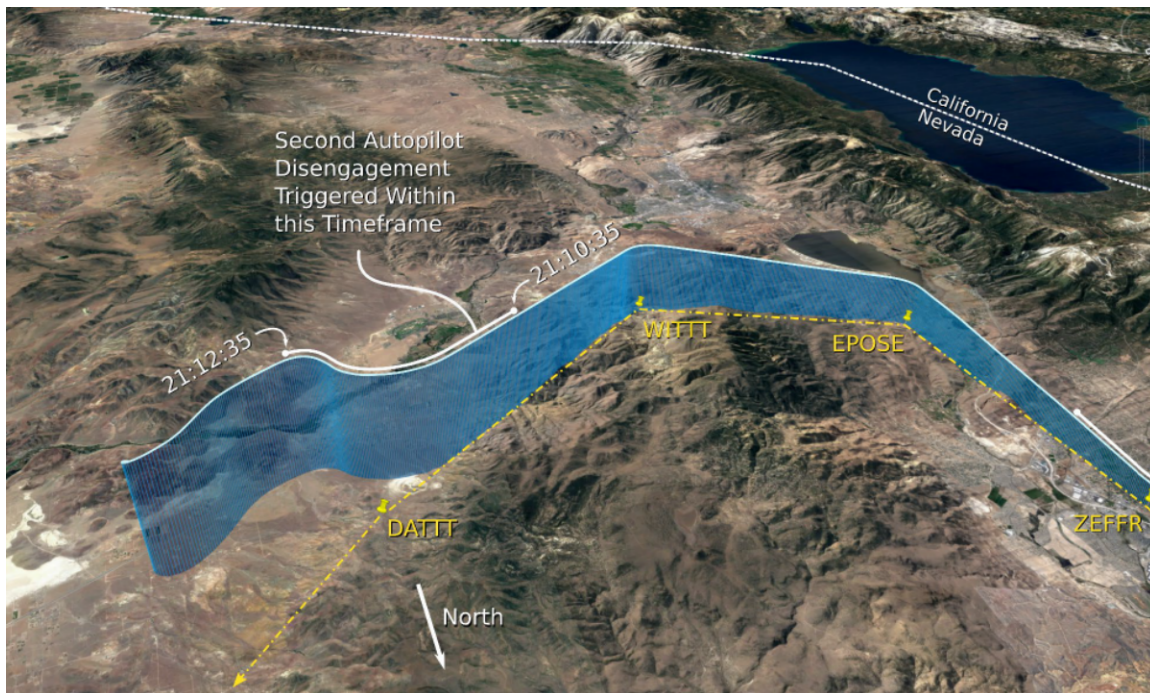
Figure 4: CAWS data map overlay showing the second autopilot disconnect.

A second autopilot disengagement occurred in minute 16 of the data, or a correlated GPS time between 2110:35 and 2112:35, as shown in figure 4.

The CAWS log did not record any annunciations between the last autopilot trim operation and the second autopilot disconnect. This gap was approximately five minutes. After the second autopilot disconnect, the pusher ice mode, pusher and (de-ice) boots green annunciators cleared.

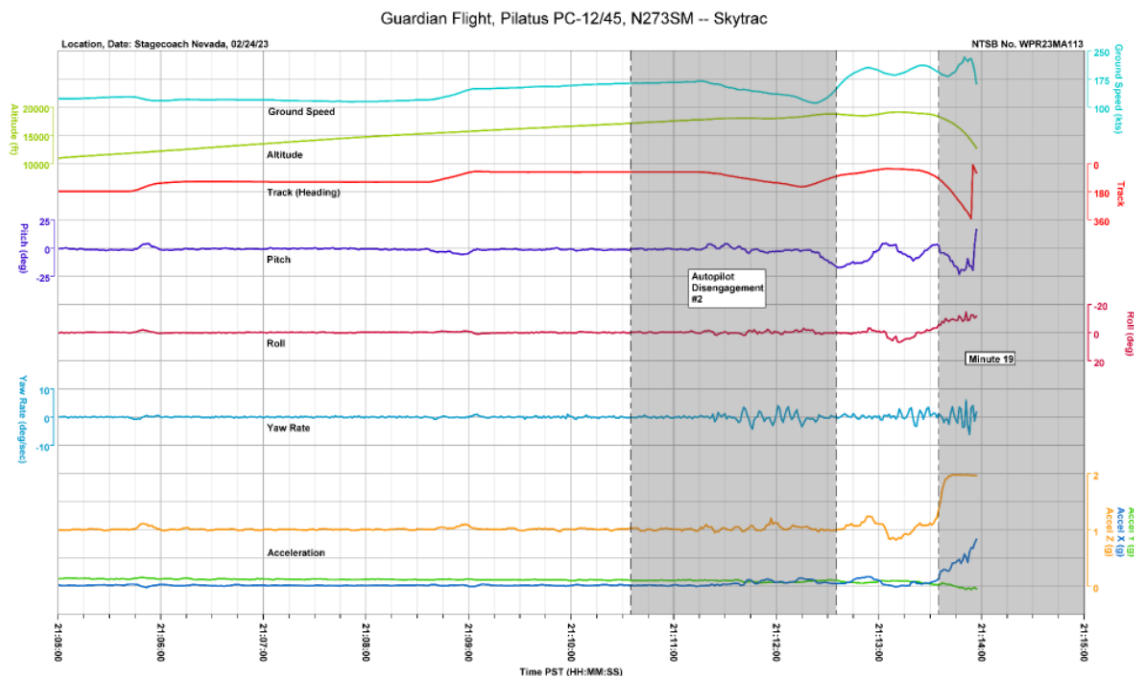
Figure 5: Plot of the accident sequence recorded by the Skytrac ISAT-200A. The estimated time frame of the second autopilot disengagement and minute 19 are shown in gray.

Data from the Skytrac transmitter (as shown below in figure 5), showed that recorded acceleration values asymptotically approached 2g, but never exceeded that value. Skytrac was asked if this was unusual and responded that "The maximum value it will display is the 2G." Pitch, roll, yaw rate, and acceleration data from the Skytrac transmitter was considered as trend data.
