# A plan for reducing wire strike accidents

## Powerline sensors, HTAWS and specialized training can significantly lower helo collision rate with cables.

**By Stuart Lau**  
ATP/FE/CFII. Boeing 747/747-400,  
757/767, CRJ, Saab 340

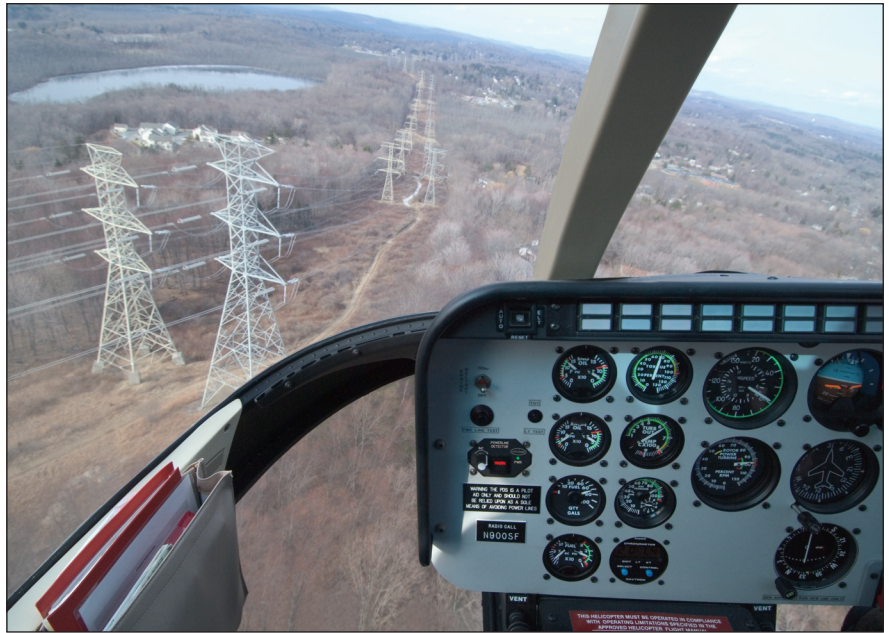
Safe Flight's powerline detection system (left side of instrument panel) "listens" for the electromagnetic signature of energized power distribution lines. As the helicopter nears the live wire, the audible tone increases in frequency, providing ample warning to the pilot to change the aircraft's flightpath.

Several power line detection systems have been developed in recent years. Safe Flight Instrument Corp’s powerline detection system (PDS) is an example of a relatively low-cost device designed to warn pilots when they near wires that are energized. Safe Flight’s PDS senses the electromagnetic field generated by live electrical power lines and emits a pulsing audible sound and visual alert. Alerts begin around 1800 ft and the frequency of the audible sound increases as the helicopter nears the wires. According to the manufacturer, only 17% of wire strikes involve de-energized lines. Thus, PDS would have effectively provided a warning in 83% of the accidents. Currently, more than 50 Safe Flight PDS systems are installed on 17 different helicopter types worldwide. Installation of the receiver, display and antenna takes approximately 2 days. Cost is roughly \$12,500.

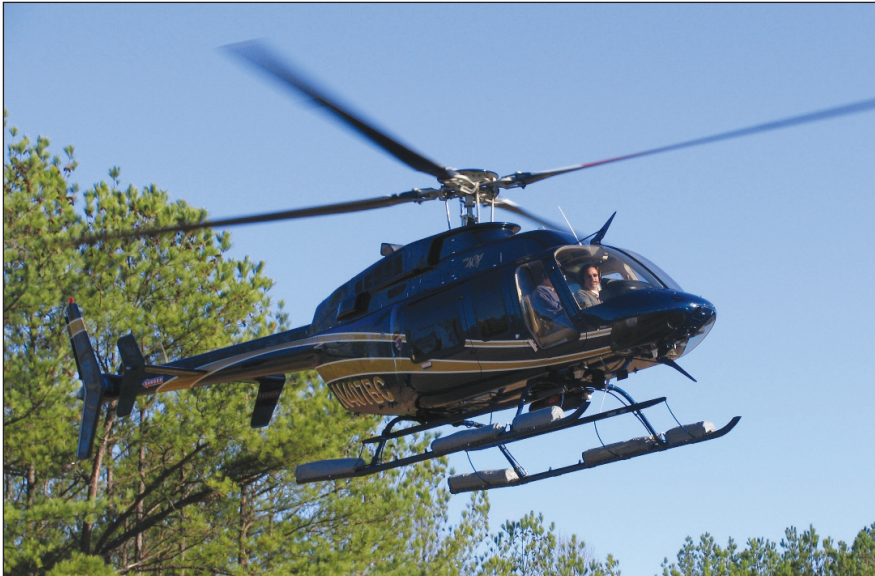
Wire strike protection system (WSPS)-equipped Bell 407 operates at low altitude. As a last line of defense, WSPS can lessen the consequences of a wire strike accident by slicing through the cable.

A WSPS or wire cutters may lessen the consequences of a frontal impact with power lines. A typical installation consists of a roof-mounted cutter and one or more other cutters on the airframe. The system also incorporates a deflector that runs vertically along the windshield.

For a WSPS to be effective, the helicopter must be flying at speeds greater than 30 kts and strike at an angle less than 60° to the wire (and  $\pm 5^\circ$  of pitch). The system is designed to cut a 3/8-in steel cable with a breaking strength of 12,000 lbs. In 1992, the US Army began equip-

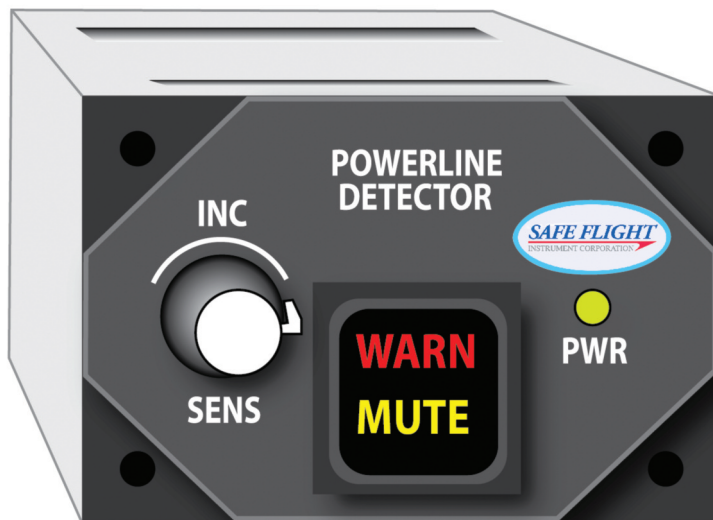
Safe Flight says its powerline detection system—a low-cost, lightweight detection system—can be installed in a helicopter in 2 days. More than 50 examples are in service on 17 helicopter types.

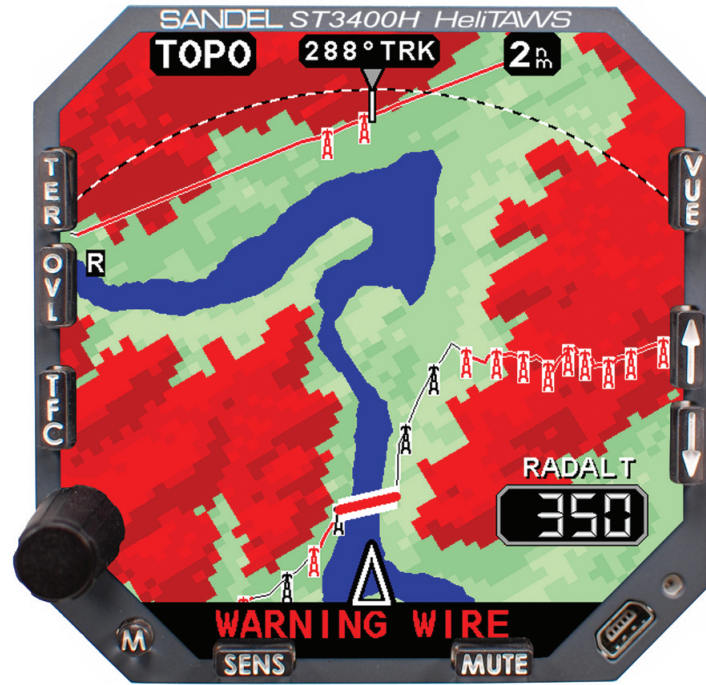
**Sandel Avionics HeliTAWS is the industry’s only multihazard avoidance system. HeliTAWS provides advance warning of terrain, obstacles and wires while virtually eliminating nuisance warnings through its proprietary algorithms.**

Sandel Avionics HeliTAWS is a unique proximity detection system that combines WireWatch—a continuously updated database of known power lines and towers—with a high-resolution terrain and obstacle database. Sandel CEO Gerry Block says, “Just as HeliTAWS itself helps pilots avoid CFIT, our WireWatch feature helps eliminate the hazard of near-invisible transmission lines by enabling helicopter

Launched during Heli-Expo 2011, HeliTAWS is the only multihazard avoidance system currently available. WireWatch provides pilots with additional situational awareness and alerting of known wires above 100 ft AGL. The database is updated using information from utility companies and operators.
